Manhole Inspection Summary

Manhole # S33Q__060MH

Insp Date: **3/17/08 11:01 AM**

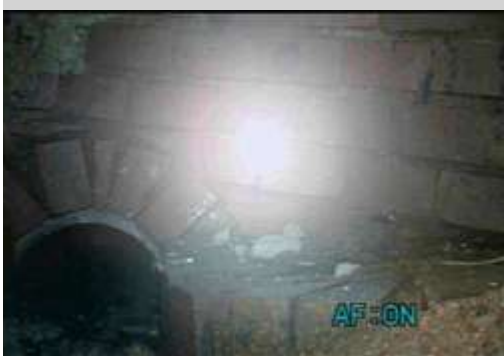
Defect 3

Condition: ☐ Sound ☐ Cracked ☐ Root Intrusion ☐ Deteriorated ☐ Leaks ☒ **Debris**

channel debris

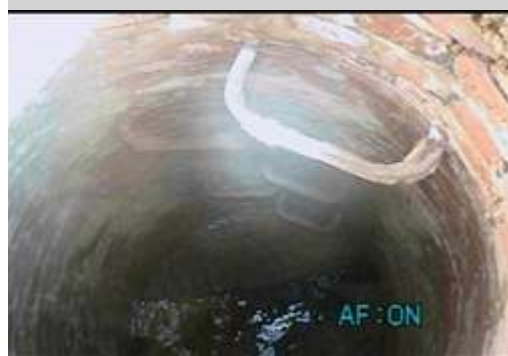
Defect 2

Count: **5** Missing: **0** ☒ **Corroded**

Steps

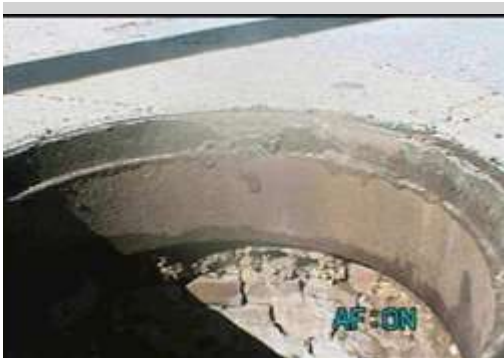
Defect 1

Offset: **1** (in.)

Condition: ☐ Sound ☐ Cracked ☐ Root Intrusion ☐ Loose Brick ☒ **Deteriorated**

frame offset, chimney deteriorated

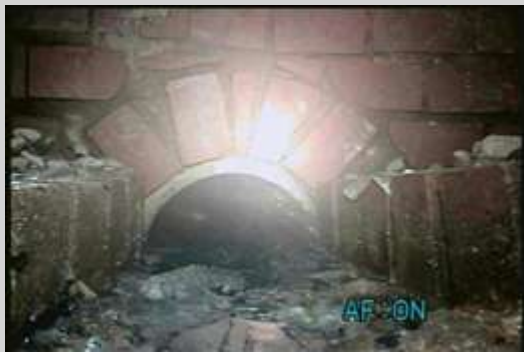
12 O'Clock Outflow

Deposits: ☐ None ☐ Mud ☐ Sludge ☒ **Debris** ☐ Grease

Silt Depth: **3** (in.) Deposits Extent: **Light**

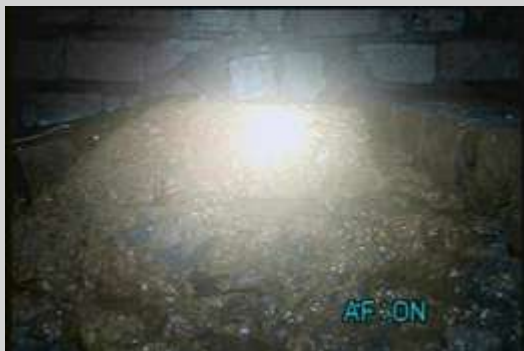
3 O'Clock Inflow

Completely blocked

Invert Depth: **9.30** (ft.) Flow Characteristics: **None**

Deposits: ☐ None ☒ **Mud** ☐ Sludge ☐ **Debris** ☐ Grease

Silt Depth: **8** (in.) Deposits Extent: **Heavy**

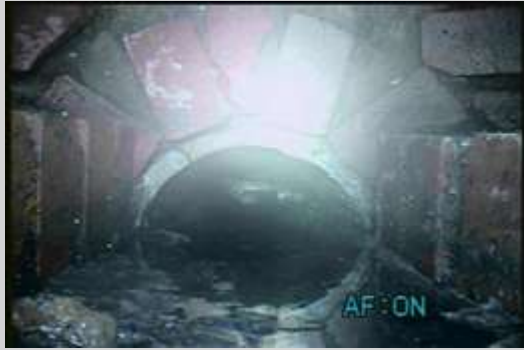
8 O'Clock Inflow

Deposits: ☐ None ☐ Mud ☐ Sludge ☒ **Debris** ☐ Grease

Silt Depth: **2** (in.) Deposits Extent: **Light**
